Husnicioara landslide investigation

Landslide field exercise

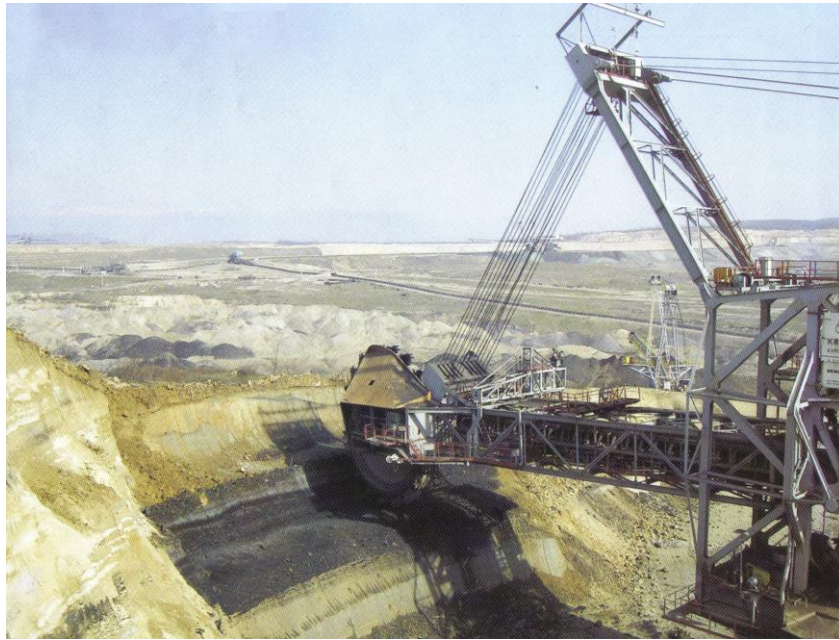
Large capacity equipment for excavation (scrapping): excavators rotor

The mine is endowed with five bucket-wheel excavators, three spreaders, one mixed machine and four deposits spreader. The total proven recoverable reserves of the mine amount to 67 million tons of lignite.

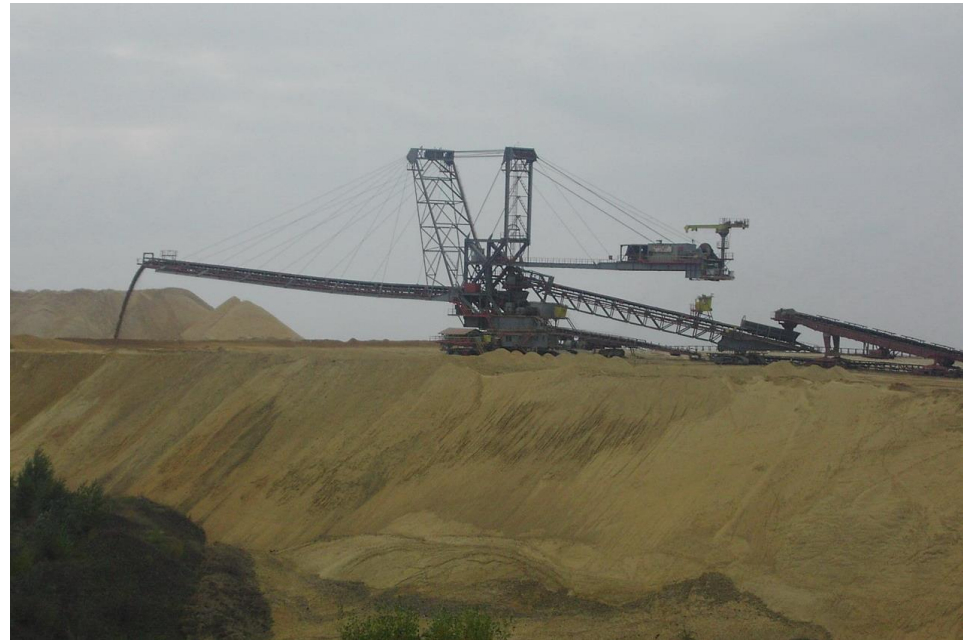
Large capacity equipment for depositing tailings

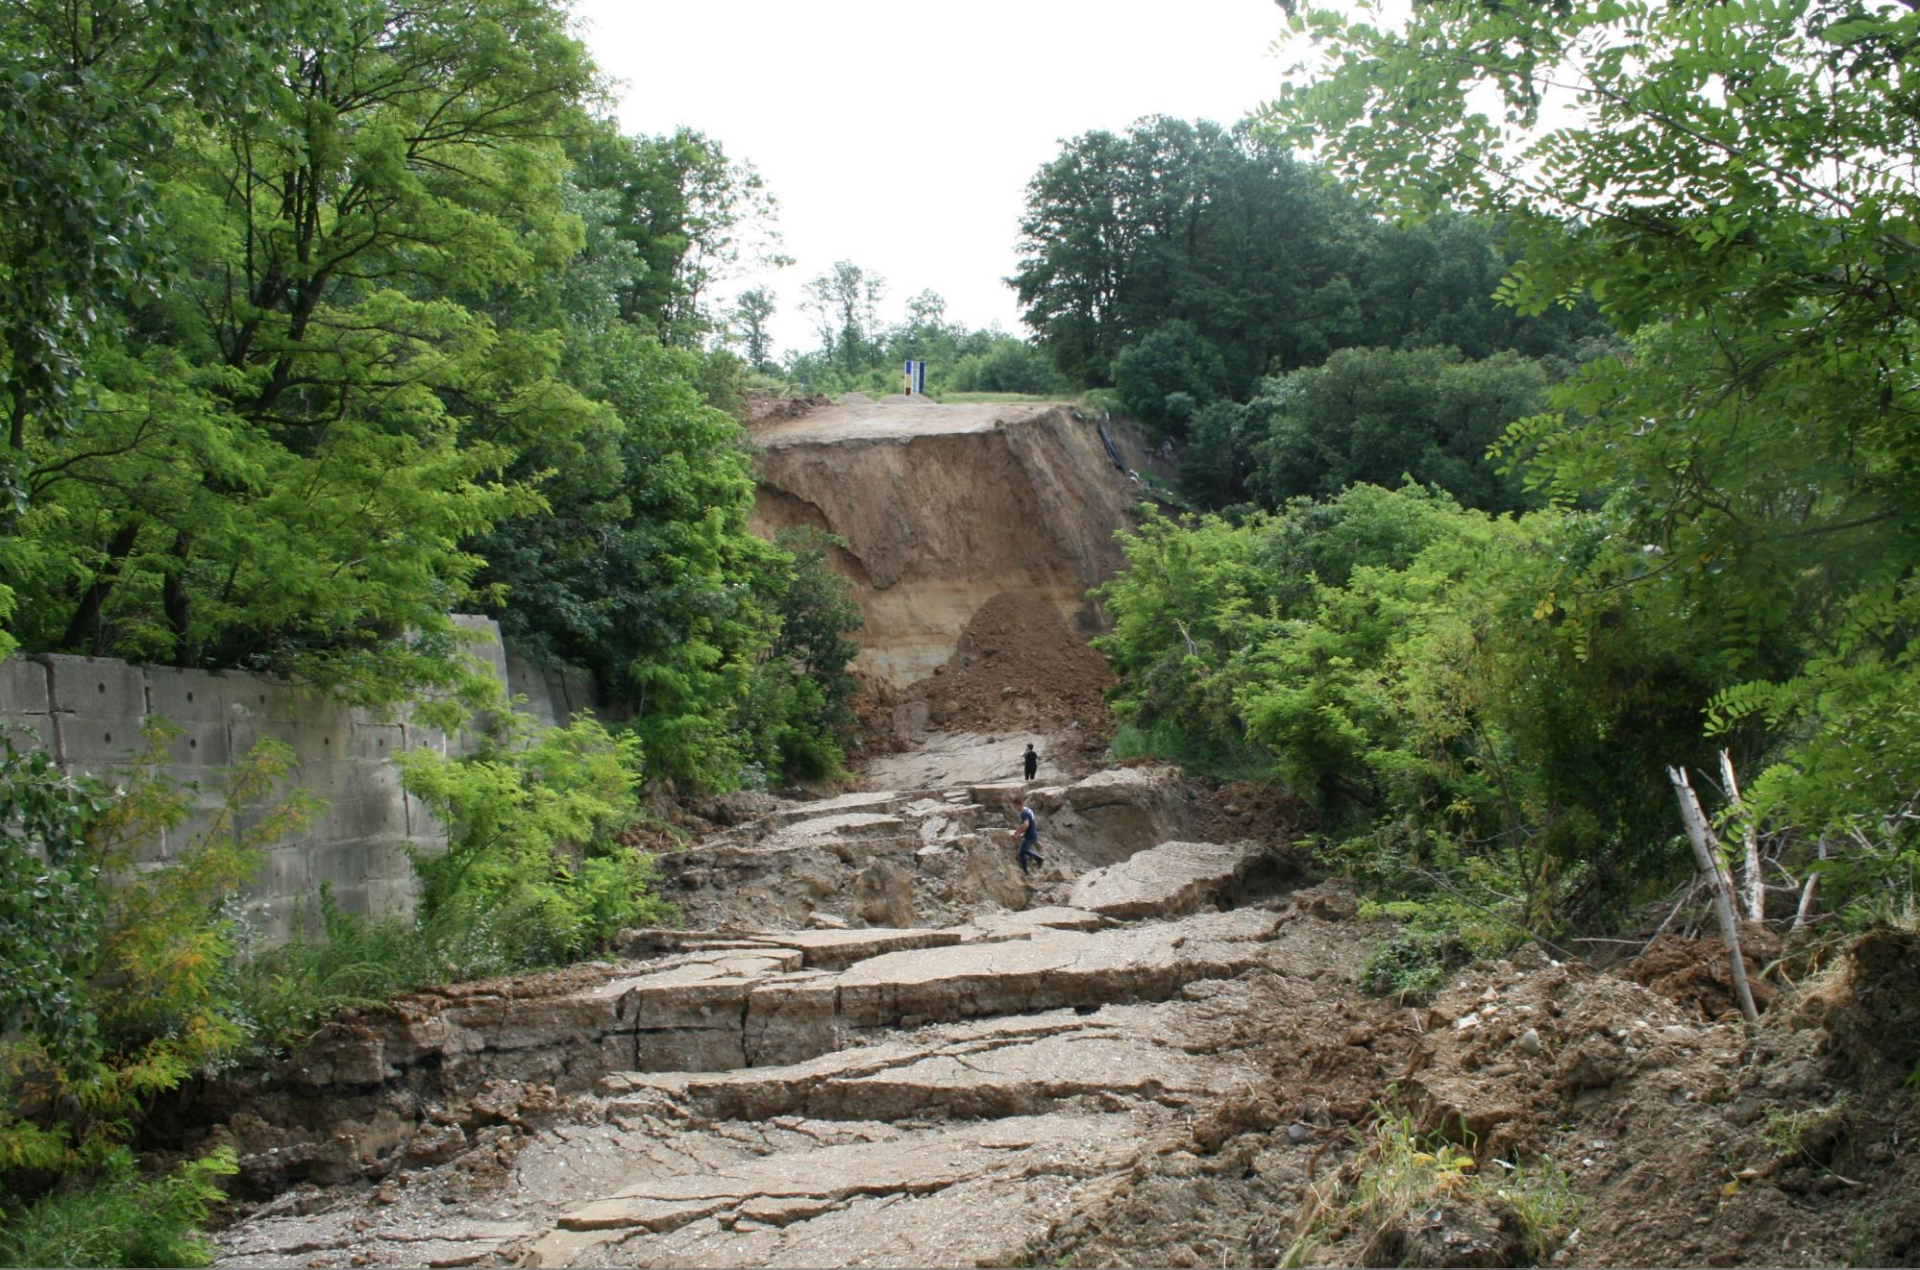
In this field exercise, ***you will make observations*** of a major lands which occurred on May 24, 2016 after a period with several heavy r and has destroyed the infrastructure in an area where under road embankment are old mine galleries from Husnicioara Coal Mine.

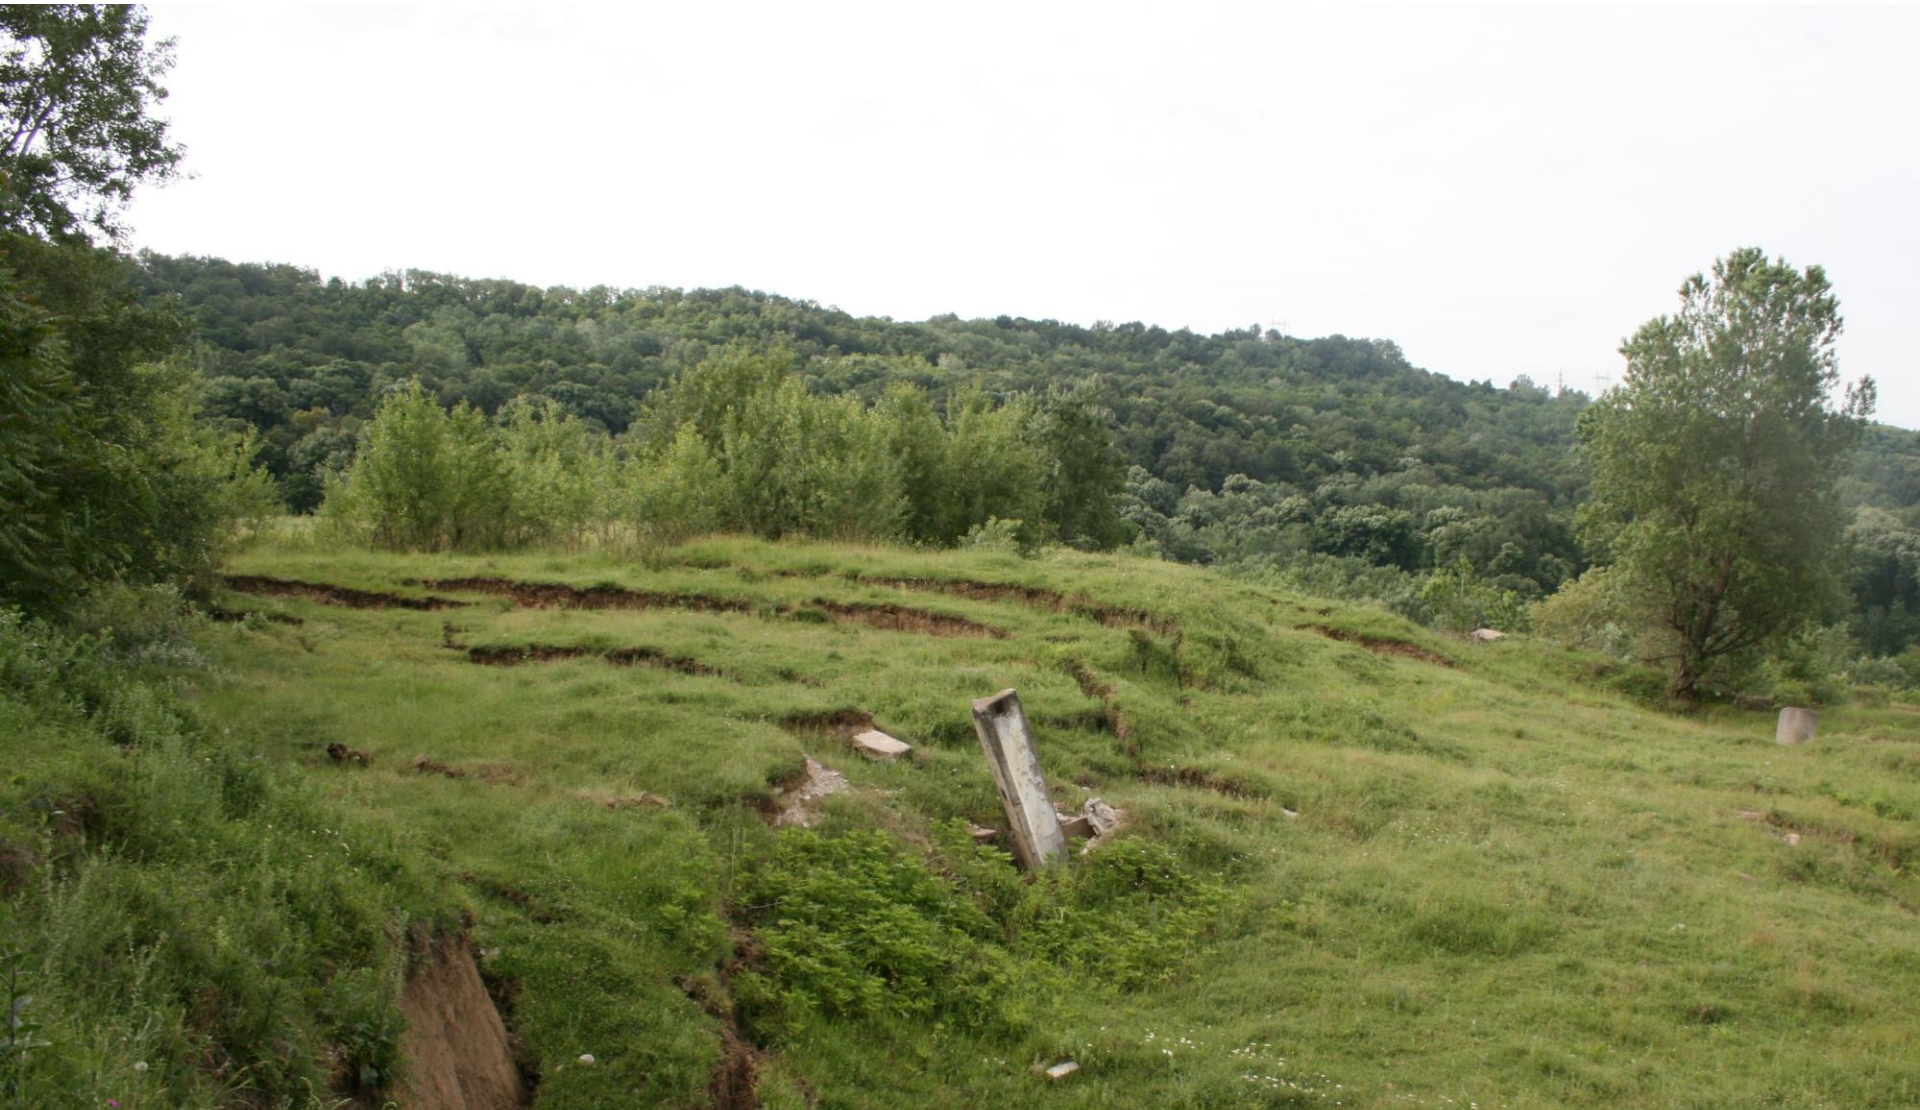
On a stretch of 500 meters, has appeared a crater up to 20 meters deep and a horizontal landslide, affecting the entire platform of the road and adjoining land.

The area where this landslide is located is affected by instability phenomena, some active, others temporarily stabilized. At triggering of the landslides compete a number of natural factors such as: lithological constitution of geological formations, mass precipitations, erosion and movement of water from seepage through masses of earth, slope energy.

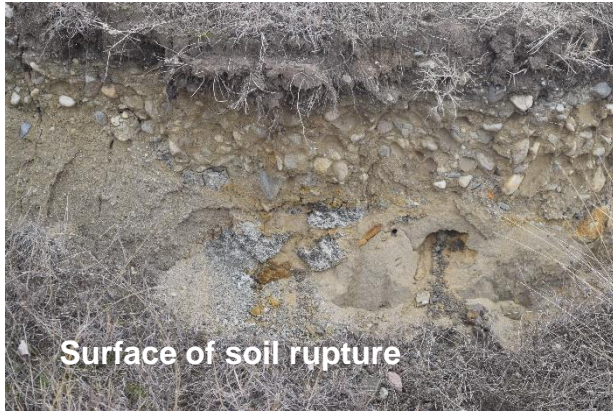
Sketch exemple

17. Sketch of the soil rupture using the symbols

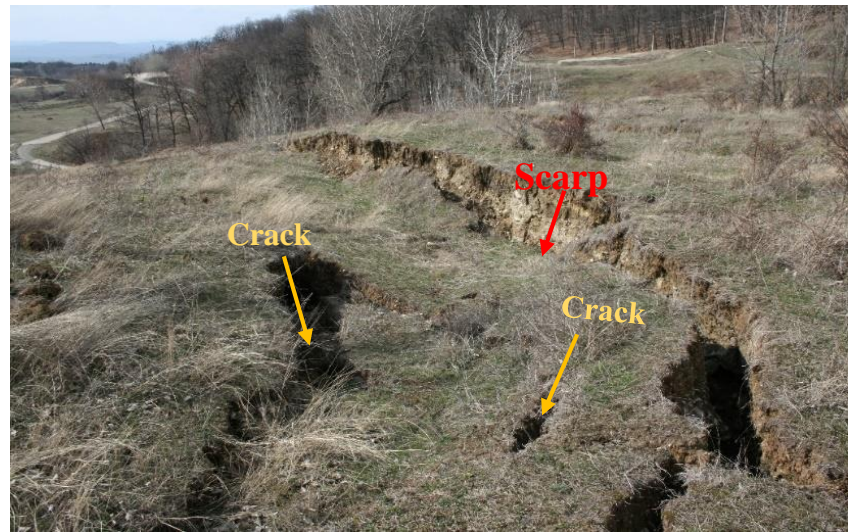
- Width - a
- Depth – b
- Length – c

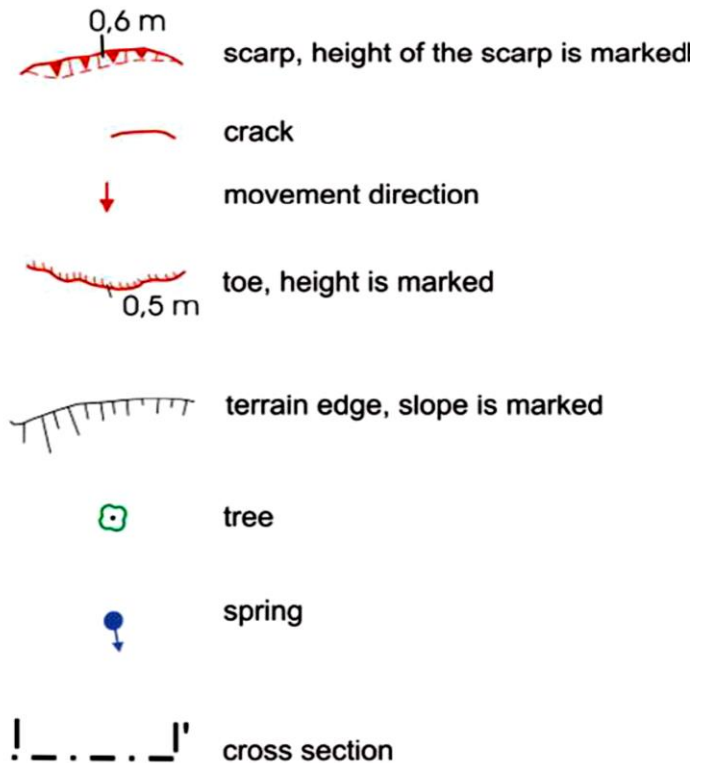
c. Make a sketch of the site using the following symbols:
